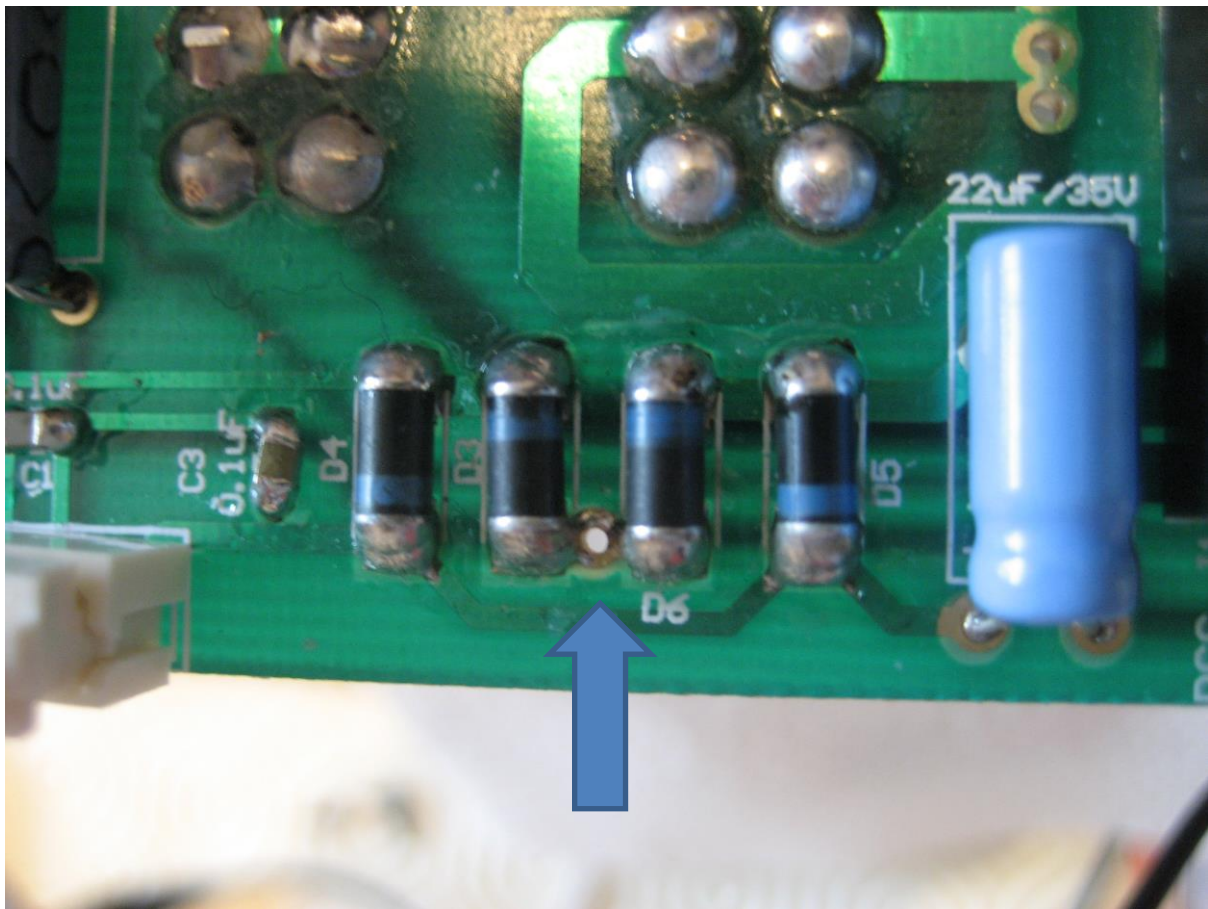
The arrow shows the plated through hole that was intermittent. A piece of wire was inserted and soldered in place. The bad connection has now gone.
