# **Joint Design Tests**

## **SUB MINIATURE BOILERS**

# Joint Design Tests for Sub Miniature Boilers

By Paul Trevaskis

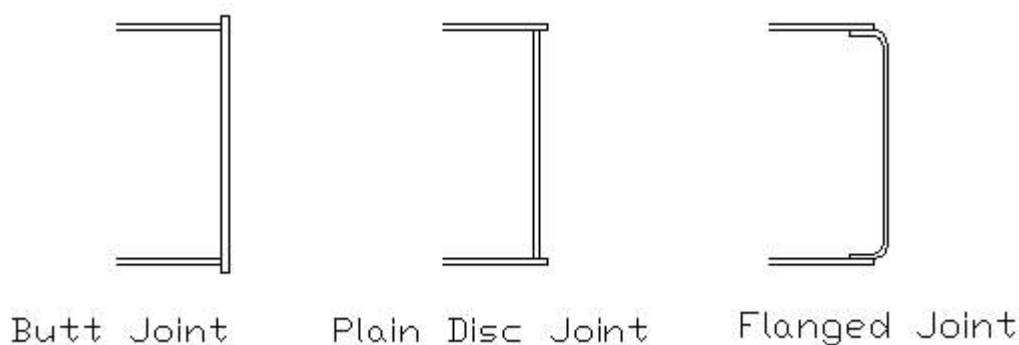
Drawing 1

In Australia there has been some discussion about the various joint construction methods, which can be used in boilers smaller than 76mm diameter. In order to test these methods a series of test pieces were constructed, and tested to destruction. The three types of joints are shown below.

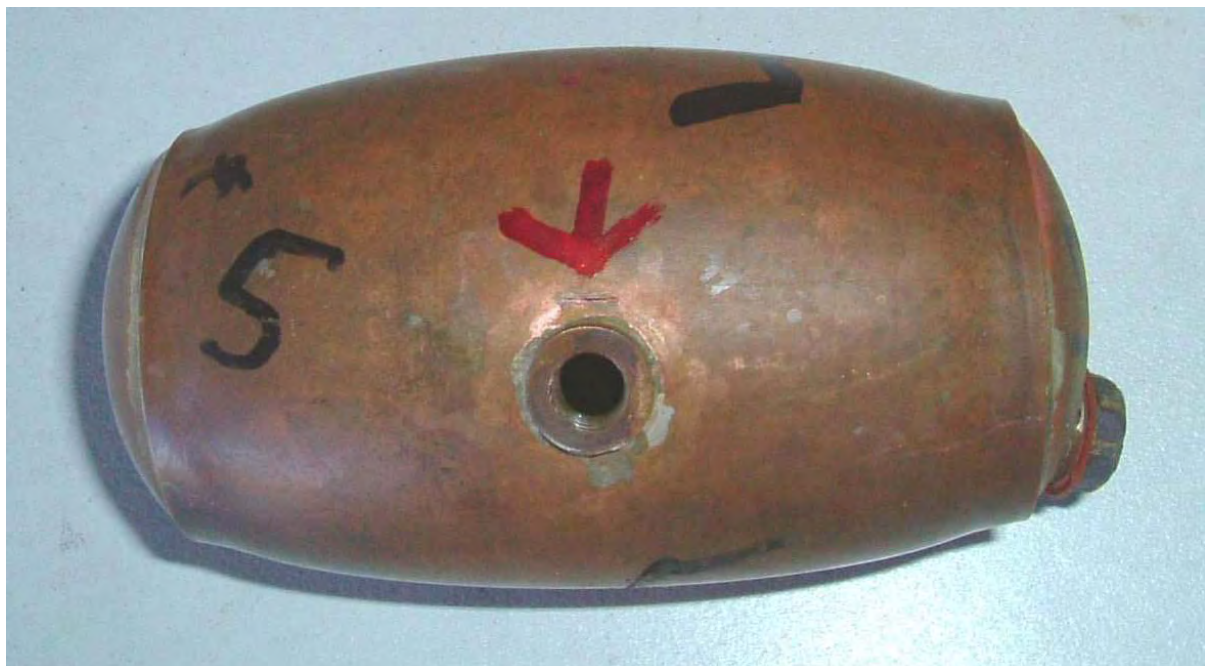
No5 Showing spilt shell near bush

- No 4            At 1000psi the joint failed on one end on top of the flue. This joint was very distorted by the collapse of the flue.
- No 5            At 1500 psi the shell split near the bush.

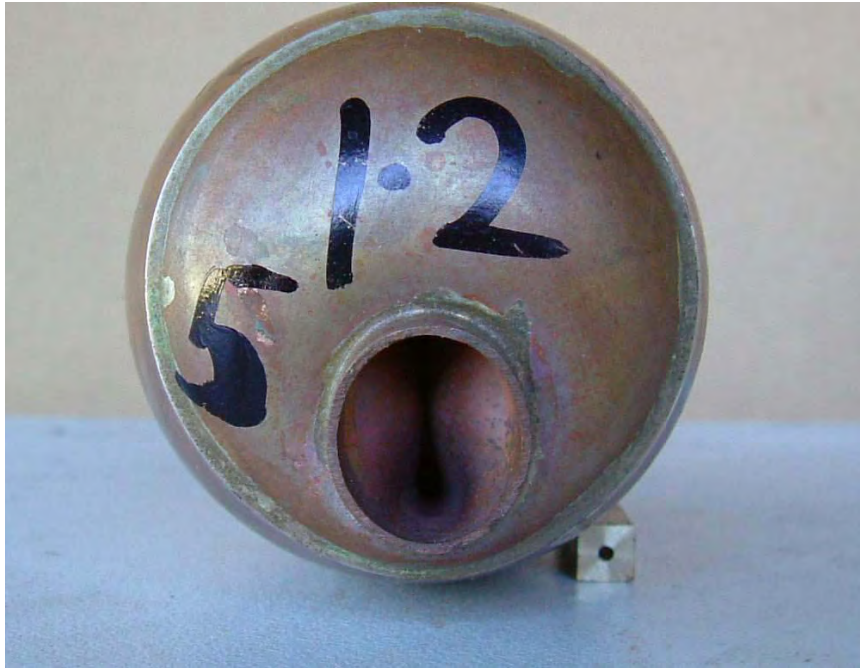
During the course of the procedure it became apparent that once the centre flues started to collapse then considerable pumping was required before the total collapse of the flue and the pressure in the piece started to rise again. The barrel and end plates would then start to expand. The end plates would be overtaken by the barrel in the expansion rate till something gave way and the piece was ruined. This is demonstrated in the following pictures.

End View of No5 showing collapsed flue.

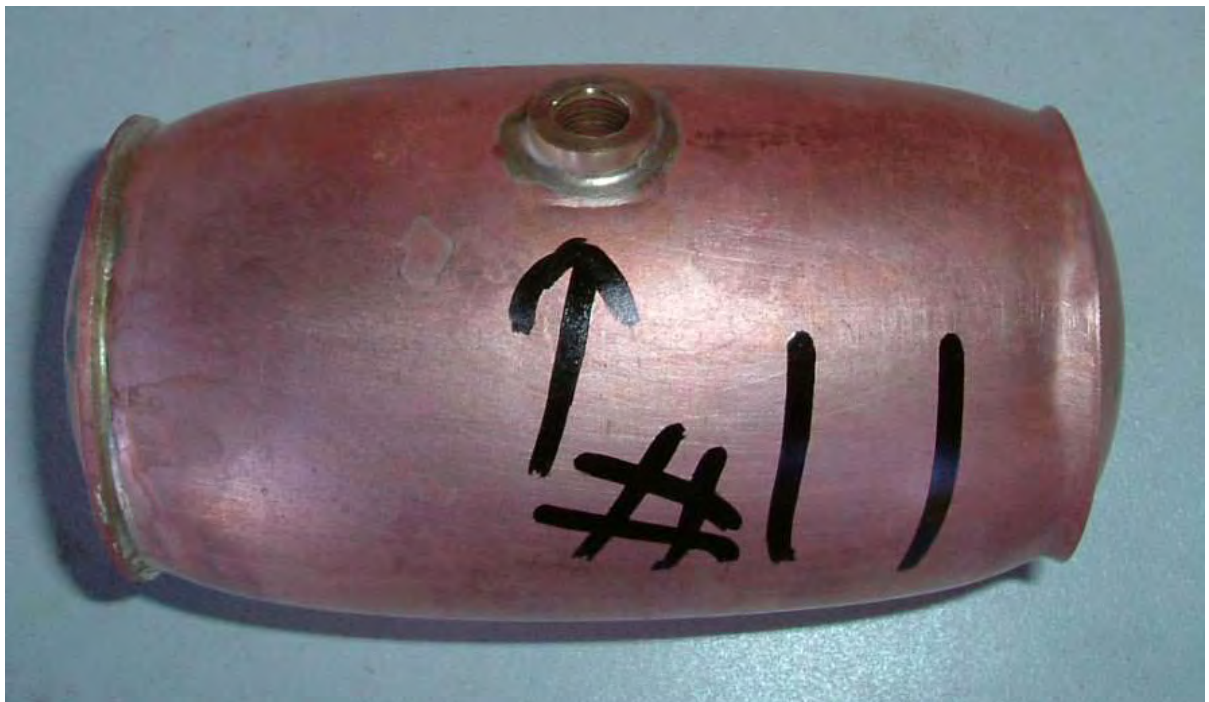
No11 Showing split shell near bush

- No 10           At 1500 psi the shell split near the bush.
- No 11           At 1500 psi the shell split near the bush.

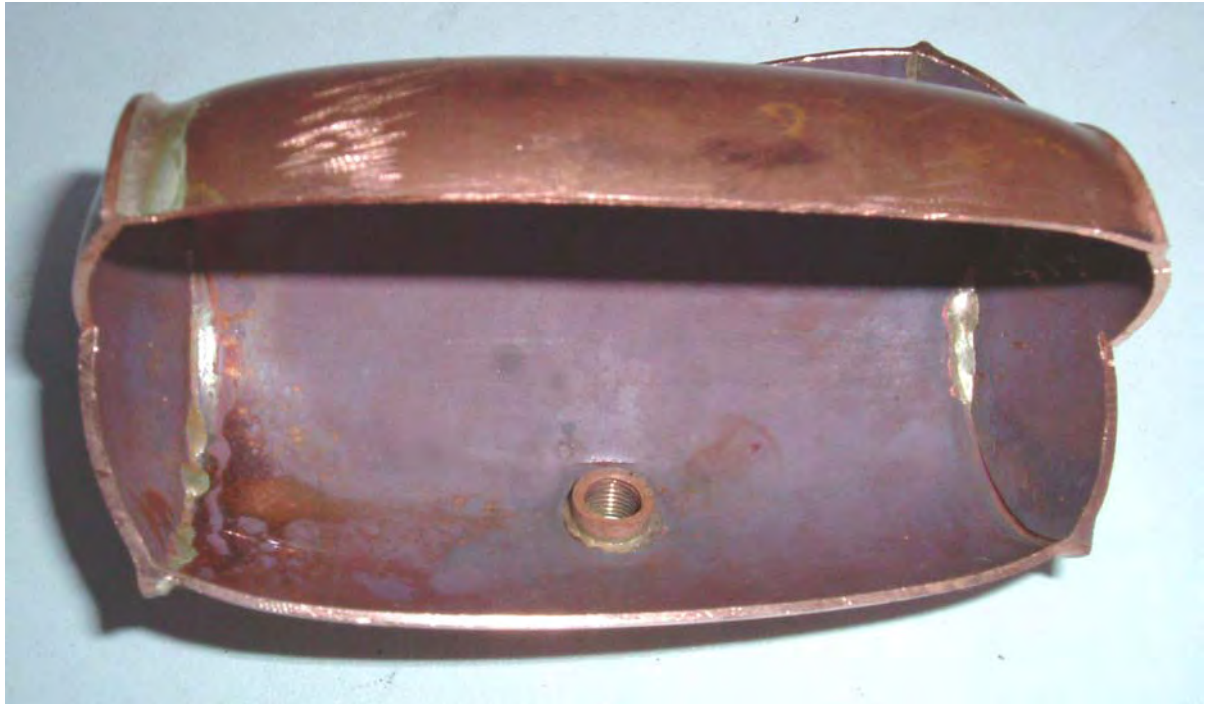
When No 11 was sectioned it was found that because of the tight fit of the disc into the barrel the silver solder had not penetrated the full width of the joint for some of the circumference of the joint.

It is interesting to note that even without full penetration of the solder the joint had not failed. Refer to the photographs of No11.

No11 Sectioned. The incomplete solder penetration can be seen on the right hand side of the piece.

Therefore a tight push fit is not recommended for this type of joint.

Even though some joints could be considered as being of poor quality, these joints were still stronger than the copper tubes used. It is recommended that joints are an easy fit to allow solder penetration.

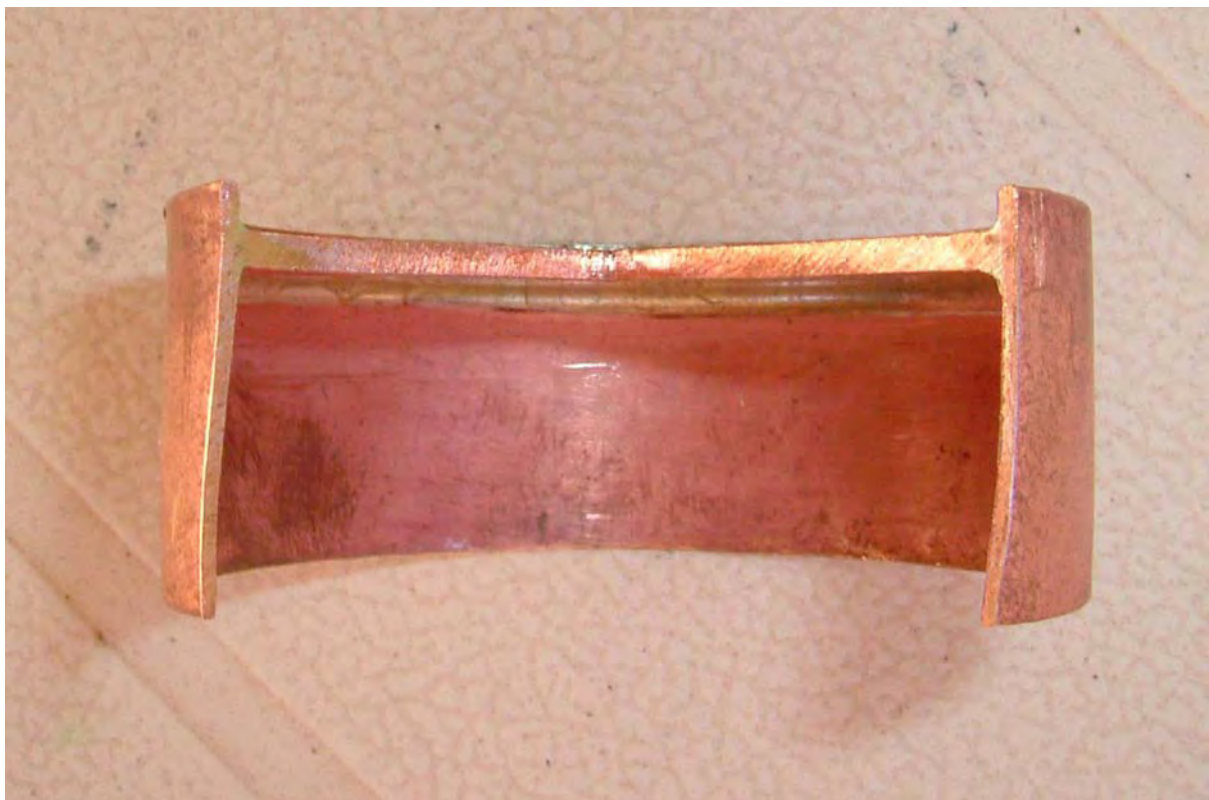
A further test piece was constructed. This consisted of a short piece of 2" copper pipe and a disc of 1/6" copper turned on a lathe to be a loose fit into the pipe. Because the pipe is not a perfect circle there was daylight to be seen around the disc with it only touching in places. It could be made to drop out by finger touch. For silver soldering it was supported on a short pillar, leaving the short end up for soldering. After pickling, there could be seen a definite ring of solder on the inside of the joint. This is easily seen in the photographs.

Section of test piece with complete solder penetration.
